Britton Falls by Del Webb HOA, Inc.

Reserve Study Funding Plan

Number of Units: 674

September 8, 2015

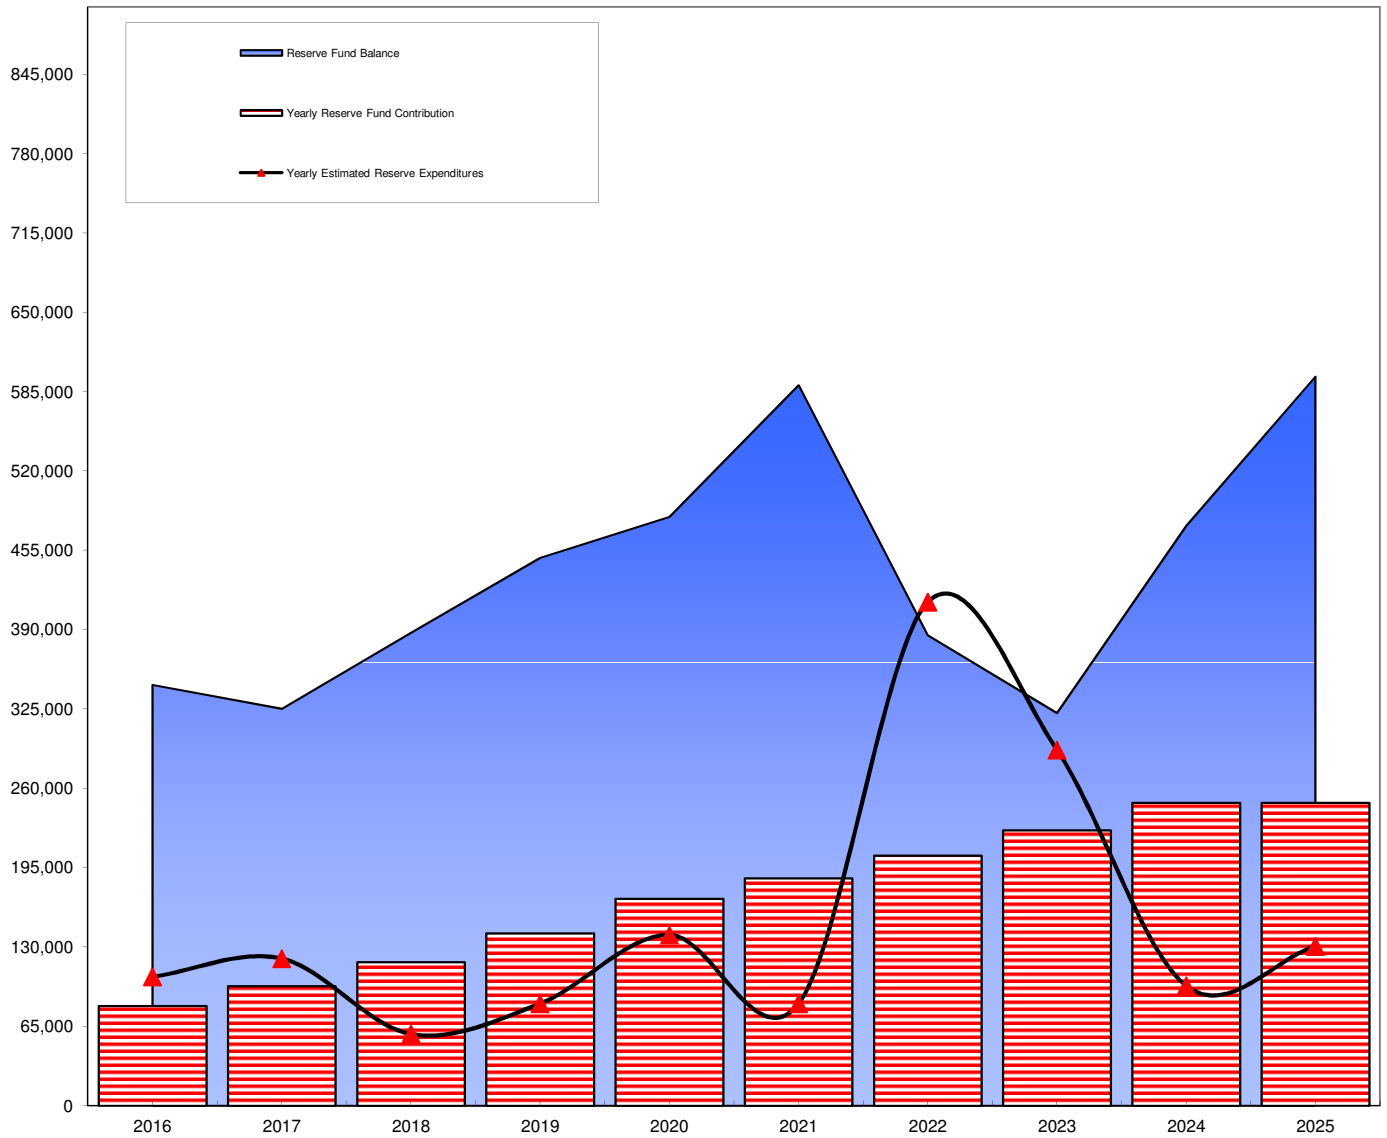
Comparative Reserve Funding & Expenditure Analysis (with recommended contributions)

Description	2016	2017	2018	2019	2020	2021	2022	2023	2024	2025
YEARLY CONTRIBUTION	81,708	98,050	117,660	141,191	169,430	186,373	205,010	225,511	248,062	248,062
ESTIMATED EXPENDITURES	105,500	120,388	58,623	83,594	139,835	83,468	412,504	291,386	98,175	130,535
INVESTMENT INCOME	3,009	2,734	3,254	3,745	3,937	4,920	2,802	2,068	3,475	4,685
END RESERVE FUND BALANCE	344,767	325,163	387,453	448,795	482,326	590,152	385,460	321,653	475,015	597,228

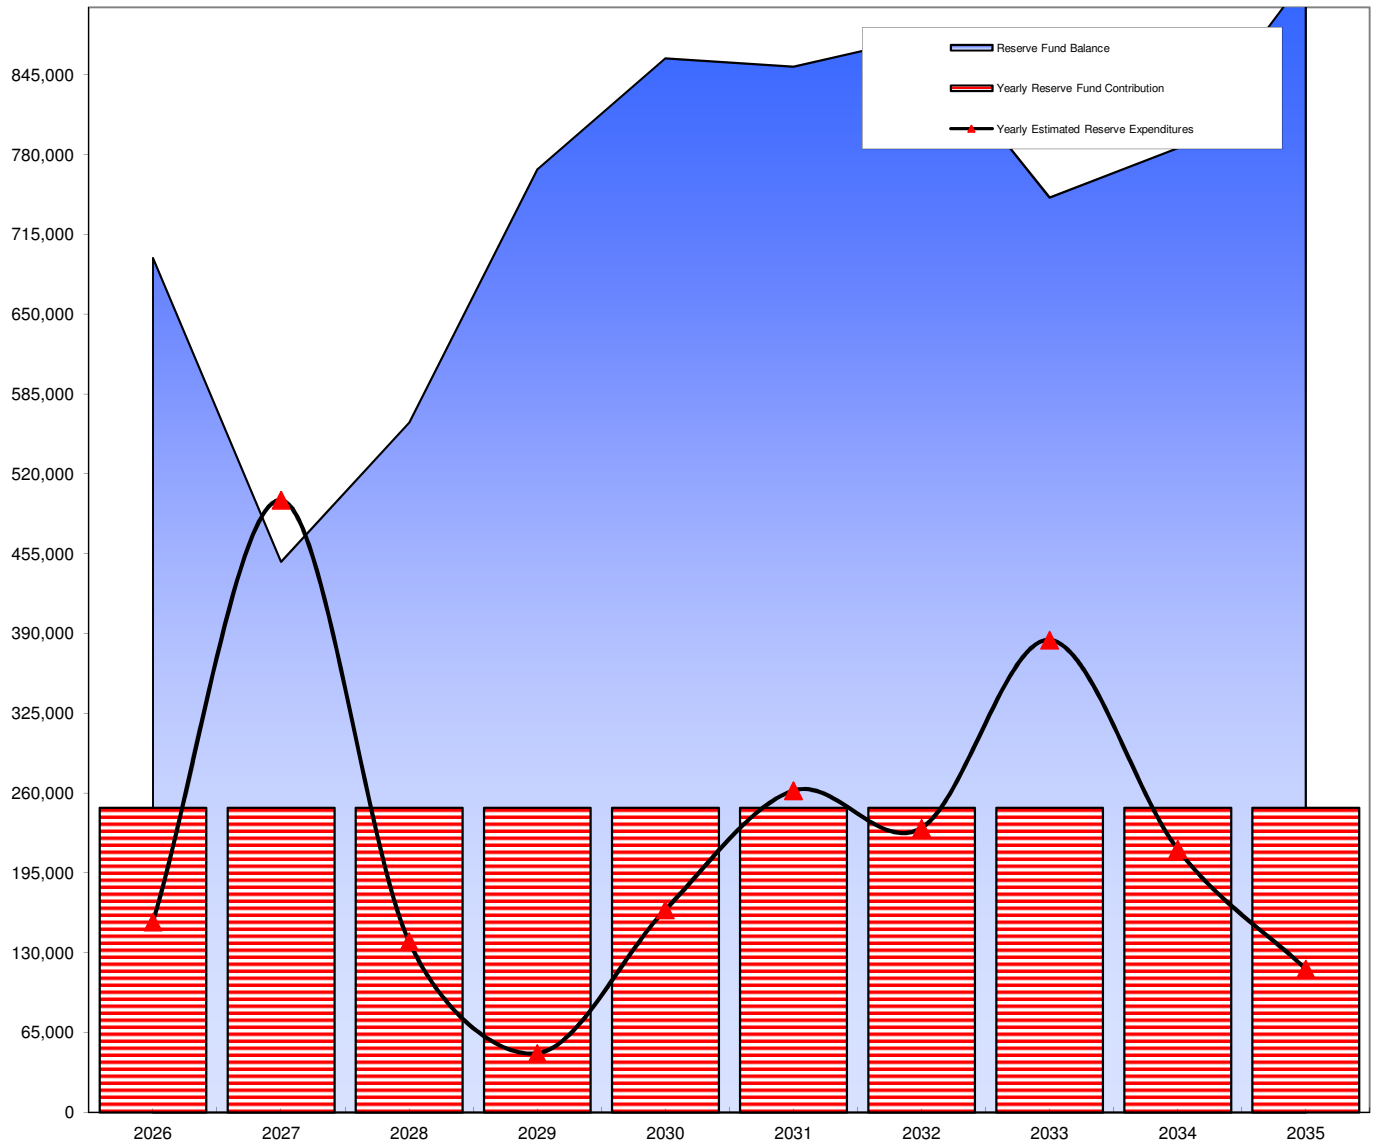
Comparative Reserve Funding & Expenditure Analysis (with recommended contributions)

Description	2026	2027	2028	2029	2030	2031	2032	2033	2034	2035
YEARLY CONTRIBUTION	248,062	248,062	248,062	248,062	248,062	248,062	248,062	248,062	248,062	248,062
ESTIMATED EXPENDITURES	155,066	498,650	139,123	48,124	164,996	261,988	231,651	384,693	214,299	116,748
INVESTMENT INCOME	5,662	3,213	4,334	6,377	7,271	7,205	7,441	6,149	6,548	7,927
END RESERVE FUND BALANCE	695,885	448,510	561,783	768,098	858,435	851,715	875,566	745,084	785,395	924,636
